Manhole Inspection Summary

Manhole # S45MM_029MH

Location Address: **20th**

Cross Street: **Chester**

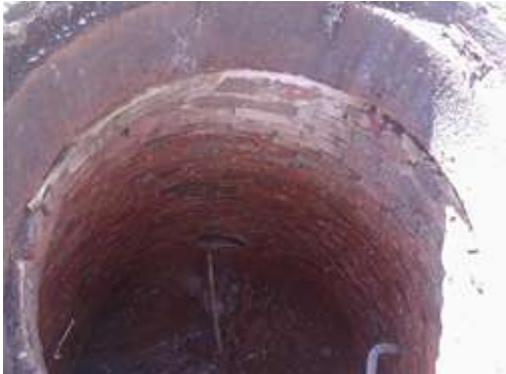
Defect 1

Adjustment Joint

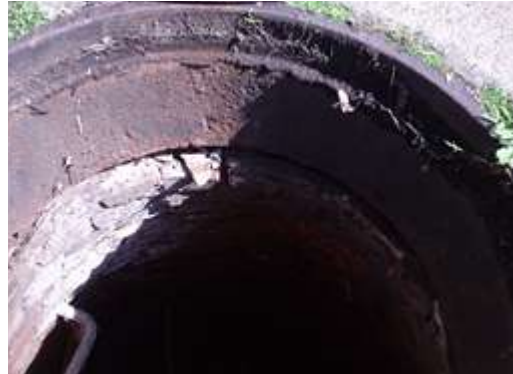
Defect 2

☒ **Leaks**

Condition: ☐ Sound ☐ Cracked ☐ Root Intrusion ☒ **Loose Brick** ☐ Deteriorated

Infiltration: ☐ None ☐ Joint ☐ Cracks ☒ **Mortar** ☐ Roots ☒ **Wall**

Frame Leaks, Loose Bricks

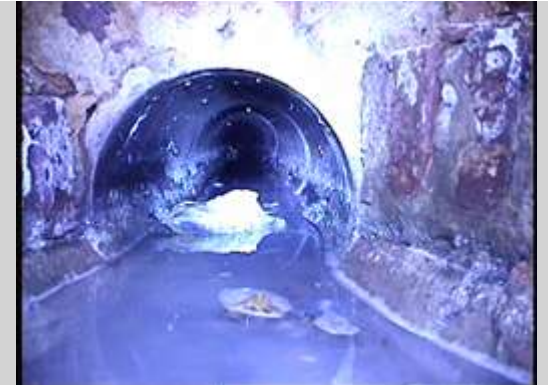
12 O'Clock Outflow

12 o'clock pipe is slower because of debris.

8 in. Circular Gravity Sewer
Pipe Out @ 12 O'Clock

Pipe Height: **8.4** (in.) Rod and Bar (Angled)
Pipe Material: **Clay** ☐ Pipe Lined
Invert Depth: **8.40** (ft.) Flow Characteristics: **Slow**
Deposits: ☒ None ☐ Mud ☐ Sludge ☐ **Debris** ☐ Grease
Silt Depth: (in.) Deposits Extent:
Infiltration: **None** Pipe Seal Cond: **Sound**

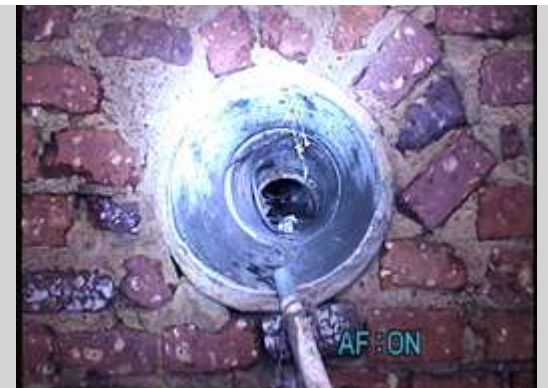
3 O'Clock Inflow

8 in. Circular Gravity Sewer
Pipe In @ 3 O'Clock

Pipe Height: **8.4** (in.) Rod and Bar (Angled)
Pipe Material: **Clay** ☐ Pipe Lined
Invert Depth: **6.90** (ft.) Flow Characteristics: **Fast**
Deposits: ☒ None ☐ Mud ☐ Sludge ☐ **Debris** ☐ Grease
Silt Depth: (in.) Deposits Extent:
Infiltration: **None** Pipe Seal Cond: **Sound**

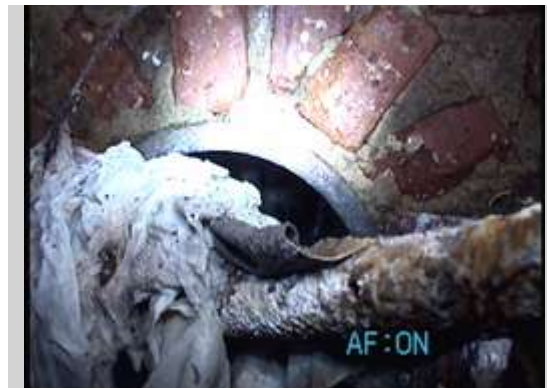
Drop In @ 3 O'Clock

Drop: **Inside** Rod and Bar
Angled: **Yes** Reading: **7.20** (ft.)
Inv Depth: **8.20** (ft.)
Drop Condition: **Partly Clogged**

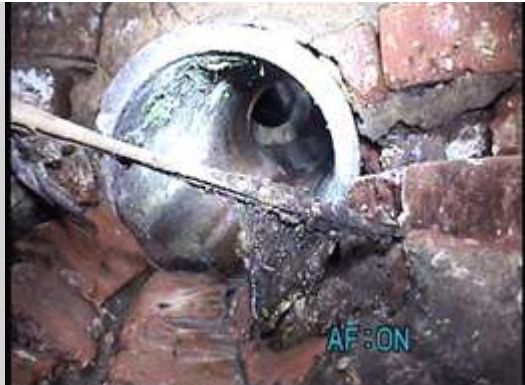
8 O'Clock Inflow

Pipe In @ 8 O'Clock

Deposits: ☐ None ☐ Mud ☐ Sludge ☒ **Debris** ☐ Grease

Silt Depth: **0.5** (in.) Deposits Extent: **Light**

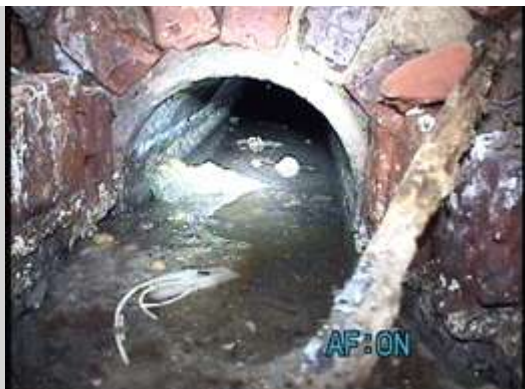
9 O'Clock Inflow

Pipe In @ 9 O'Clock

Invert Depth: **8.15** (ft.) Flow Characteristics: **None**

Deposits: ☐ None ☒ **Mud** ☒ **Sludge** ☒ **Debris** ☐ Grease

Silt Depth: **3** (in.) Deposits Extent: **Medium**
